Technical Report REMR-CS-60
September 1998

Repair, Evaluation, Maintenance, and Rehabilitation Research Program

Performance Criteria for Concrete Repair Materials, Phase II Field Studies

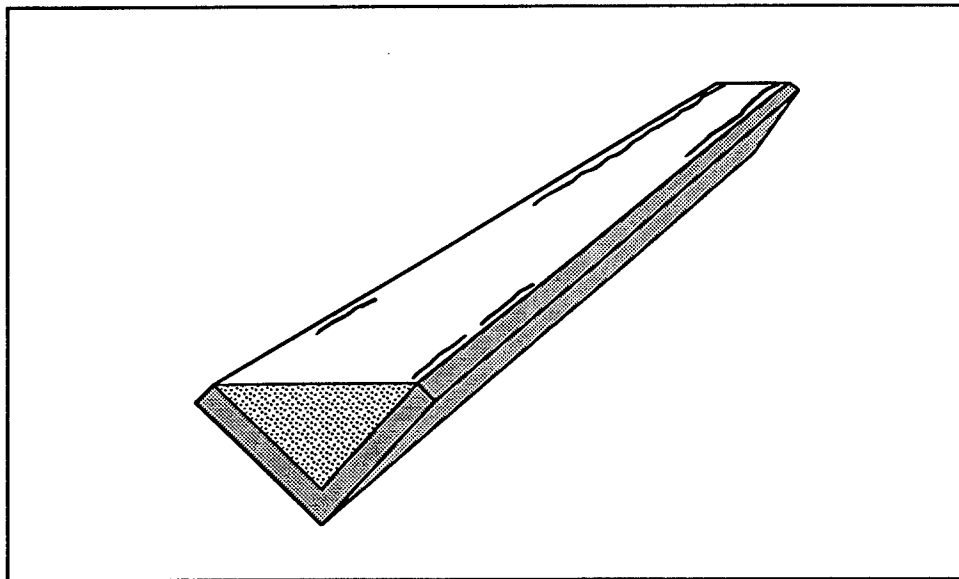
Figure 53. Cracking of Material No. 6 (Arizona)

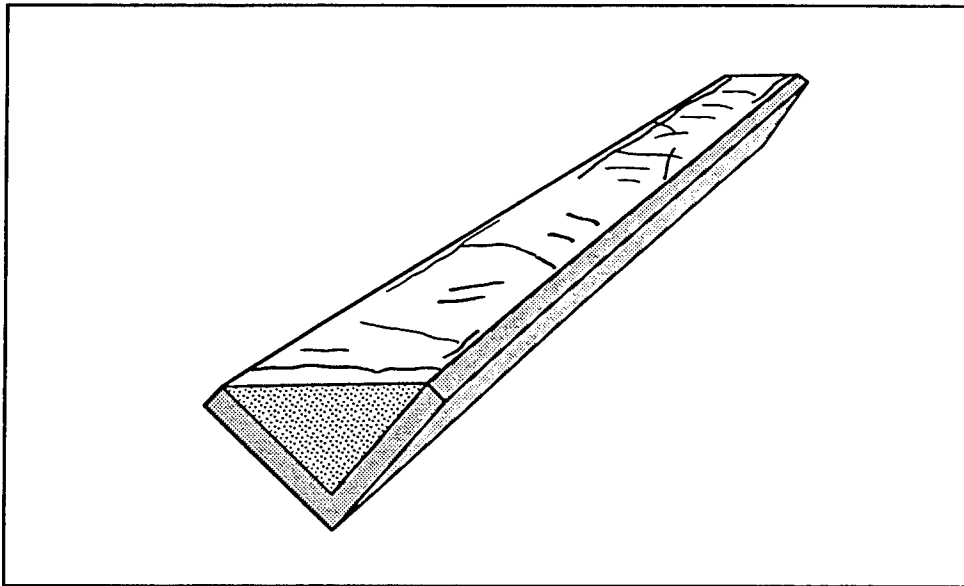
Figure 54. Cracking of Material No. 7 (Arizona)

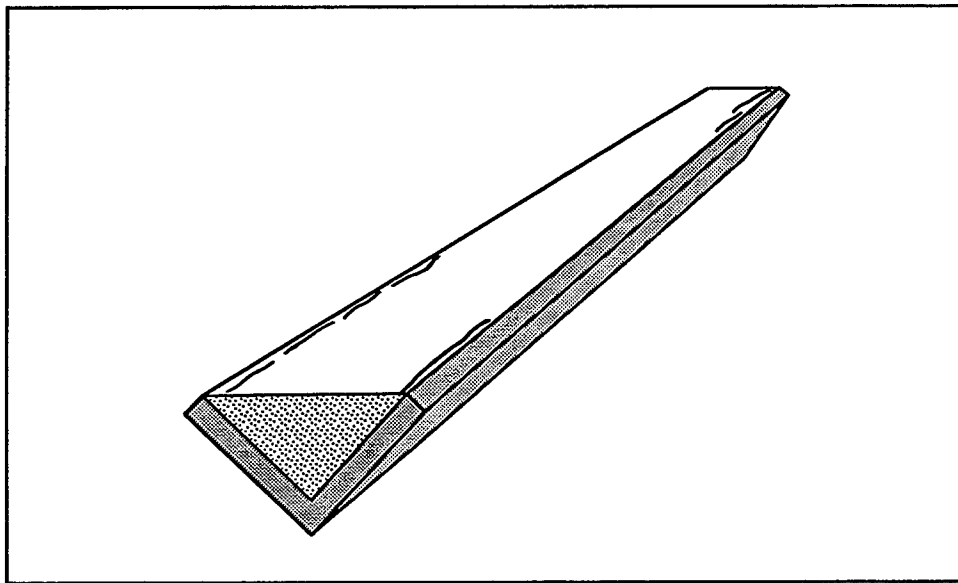
Figure 55. Cracking of Material No. 8 (Arizona)

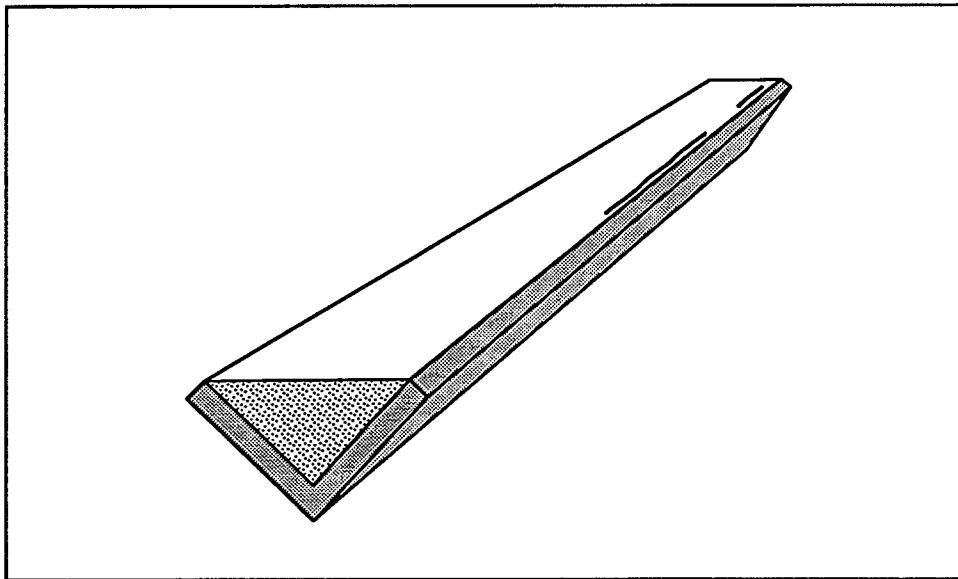
Figure 56. Cracking of Material No. 9 (Arizona)

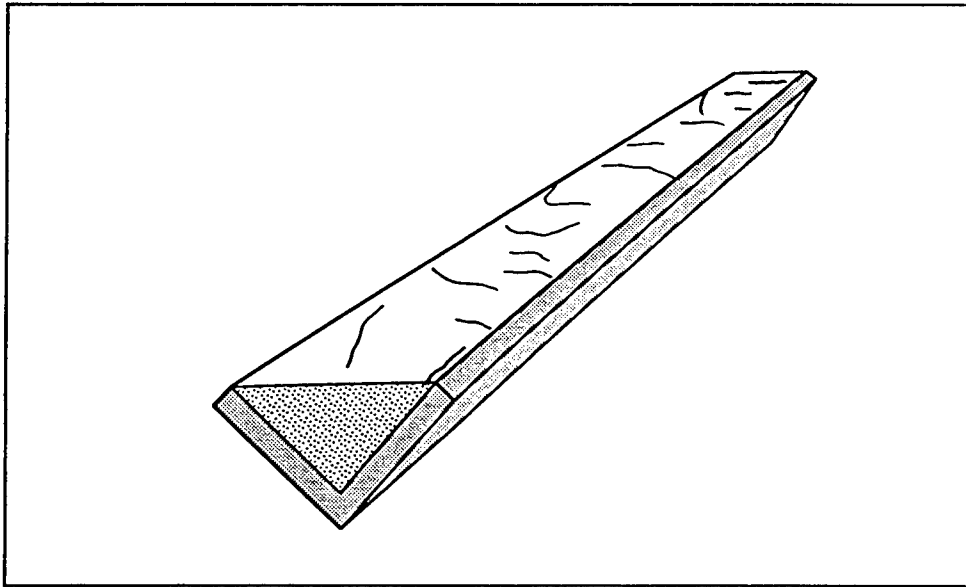
Figure 57. Cracking of Material No. 10 (Arizona)

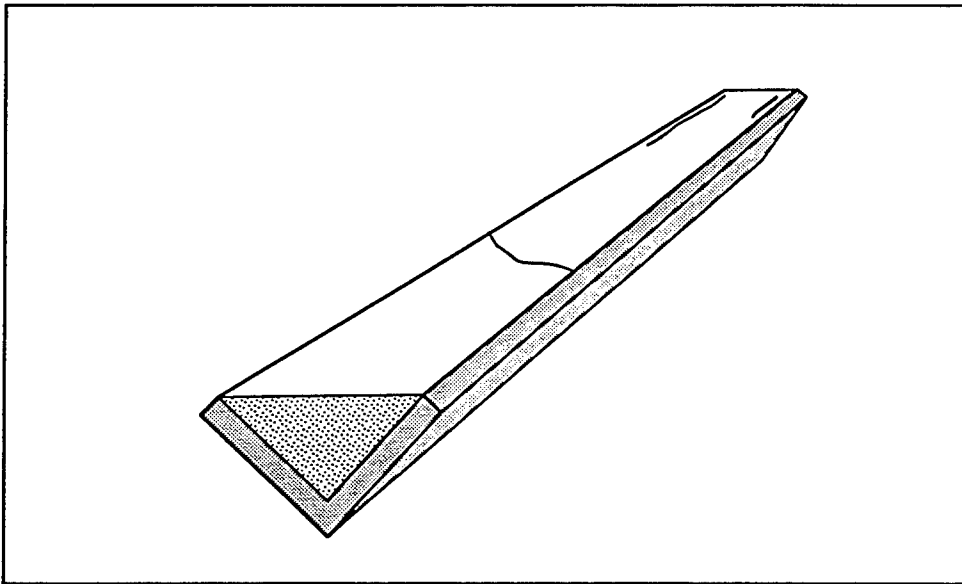
Material No.	Date of Placement	Observation
1	12/06/94	No cracks.
2	12/06/94	No cracks.
3	12/06/94	Three cracks noted at 7 days. Figure 52.
4	12/07/94	No cracks.
5	12/07/94	No cracks.
6	12/07/94	Two cracks noted at 7 days; three additional cracks at 21 days; one additional crack at 35 days. Figure 53.
7	12/07/94	Twelve cracks noted at 7 days; two additional cracks at 21 days; one additional crack at 28 days; two additional cracks at 35 days; one additional crack at 42 days; one additional crack at 170 days; four additional cracks at 200 days; one additional crack at 240 days. Figure 54.
8	12/08/94	Two cracks noted at 7 days; five additional cracks at 170 days. Figure 55.
9	12/08/94	One crack noted at 7 days; one additional crack at 35 days. Figure 56.
10	12/08/94	Thirteen cracks noted at 7 days; one additional crack at 35 days. Figure 57.
11	12/09/94	One crack noted at 7 days; one additional crack at 21 days; one additional crack at 200 days. Figure 58.

Figure 58. Cracking of Material No. 11 (Arizona)
